**Flood Control Project Maintenance  
Levee Inspections**

**Maintenance Issue Types Only, Levee Inspection Report By Mile - Spring 2019**

**Sutter Maintenance Yard East Levee Sacramento River**

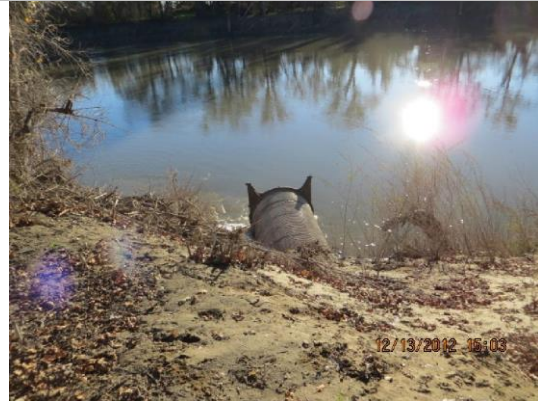
Photo 1 of 3 : UCIP\_SP\_2019\_51650\_46962.jpg

Waterside view: overview towards CMP sewer pipe

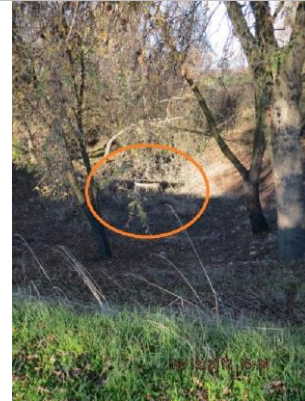
Photo 3 of 3 : UCIP\_SP\_2019\_51650\_46961.jpg

| FS_ID:51650<br>DS_ID:17307<br>EP_NO: 9534<br>Repair Type: No Action Needed<br>Crossing Status: Found<br>UCIP Comments: 10/27/2017 This structure is inspected annually under the Structure and Channel Summer Inspection (part of the Levee Inspection Program) conducted by the DWR Flood Project Integrity and Inspection Branch (FPIIB). (DWR UCIP - O. Magana)<br>4/24/2017 Both sides of crossing were underwater during site visit. Will need to revisit after water levels drop. (DWR Sutter Yard- A Freitag) 11/7/2016 Crossing appears to be in good condition. (DWR Sutter Yard- A Freitag) 6/6/2016 Crossing appears to be in good condition. 4/6/2015 Good Condition. No issues. Semi circle CMP half riser in inlet structure on LS. Inlet opeing has no trash rack, this may cause safety issue. 6/30/2014 Same as last inspection. 12/30/2013 Same as last inspection. 7/29/2013 Same as last inspection.<br>FIELD_STRUCT_DESC: [Butte Slough Drainage Structure] 78-inch drainage pipe of an unknown material through the levee, 3 feet below the crown. Flap gate on the waterside (WS). Corrugated metal pipe (CMP) half riser (in a semi-circle configuration) in the inlet structure on the landside (LS). (78-inch pipe [HLM 0.44] authorized under Automatic Board Order (ABO) issued as Permit No. 9534, 1974 - Caleta).<br>[Additional Reference(s): DWR Levee Log, 2002. USACE Sacramento O&M Manual 136, March 1960 (HLM 0.44)].<br>FS Date: 4/26/2017 9:46:51 AM | | | | | |

Landside view: overview

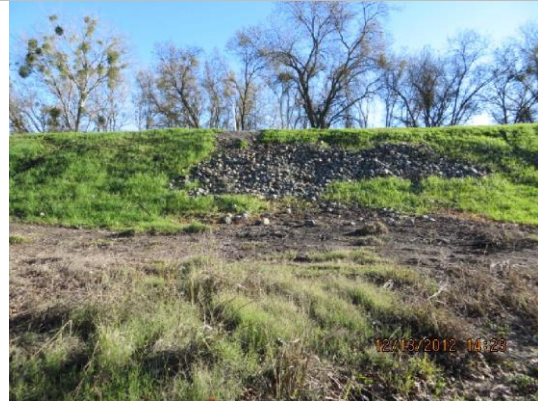
Photo 3 of 3 : UCIP\_SP\_2019\_53400\_46990.jpg

FS\_ID:53400  
DS\_ID:17320  
EP\_NO: 9543  
Repair Type: Urgent  
Crossing Status: Found  
UCIP Comments: 8/30/2018 WS vegetation too thick to clearly inspect WS pipe so assume same condition as last inspections so crossing remains Urgent due to pipe integrity. WS levee slope looks good. No signs of levee threat to the road crown. LS headwall looks in good condition (D. Sanoski - DWR UCIP).4/24/2017 WS was underwater during the site visit but I do not believe that any repairs have been made to this crossing yet. (DWR Sutter Yard- AFreitag)11/7/2016 No repairs have been made here yet. (DWR Sutter Yard- AFreitag)6/17/2016 River levels were down and the WS pipe end was exposed. WS end is completely rotten and damaged and flap gate has fallen off the end of the pipe (see pics). Pipe needs to be replaced or repaired. (DWR Sutter Yard - afreitag)4/5/2016 Erosion on WS slope still present. Pipe still fully submerged on WS and discharging into river during site visit. (DWR UCIP - kfazel)4/6/2015 Pipe leaks during high water. DWR employee said he suspects that the flap gate has rotted and fallen off WS end of pipe. Could not locate WS end of pipe to confirm. Water was flowing through this drain during field survey. (DWR Sutter Yard - afreitag)6/30/2014 Same as last inspection. (DWR Sutter Yard - afreitag)12/30/2013 Same as last inspection. (DWR Sutter Yard - afreitag)7/29/2013 Same as last inspection. (DWR Sutter Yard - afreitag) 12/13/2012 Water was flowing through this drain during field survey. (DWR UCIP - pamatya)

FIELD\_STRUCT\_DESC: 30-inch corrugated metal drainage pipe (at 45 degrees) through the levee, 25.2 feet below the crown. Flap gate on the waterside (WS), not found in 2016. (30-inch pipe [HLM 1.38] authorized under Automatic Board Order (ABO) issued as Permit No. 9543, 1974 - Harada). [Additional Reference(s): DWR Levee Log, 2002. USACE Sacramento O&M Manual 136, revision March 1960 (HLM 1.38)]  
FS Date: 8/30/2018 1:02:00 PM

Landside view: overview of levee slope

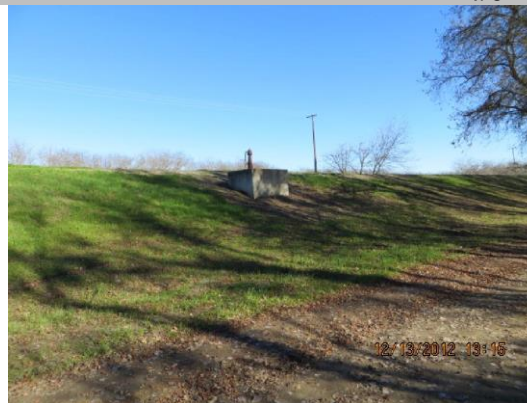
Photo 1 of 3 : UCIP\_SP\_2019\_51660\_47027.jpg

| FS_ID:51660<br>DS_ID:17309<br>EP_NO: 9541<br>Repair Type: Non-Urgent<br>Crossing Status: Found<br>UCIP Comments: 4/24/2017 Still no sign of WS pipe end or flapgate.<br>LS appears to be in good condition. (DWR Sutter Yard- AFreitag)<br><br>11/7/2016 LS culvert measured to be 30"wide X 30"tall. WS end is not visible so could not be measured. (DWR Sutter Yard- AFreitag)6/6/2016 Cannot locate the WS headwall/flapgate. Appears to have been silted over.4/6/2015 Same as last inspection. Concrete surg box on WS. Flap gate in concrete "U" headwall at the waterward end- not found.6/30/2014 Same as last inspection.12/30/2013 Same as last inspection.7/29/2013 Same as last inspection.<br>FIELD_STRUCT_DESC: 30-inch reinforced concrete box drainage culvert through the levee, 14.3 feet below the crown. 30-inch corrugated metal pipe connects concrete culvert from slide gate out to flap gate on the waterside (WS) end. Slide gate in a concrete riser on the waterside (WS) slope. (30-inch pipe [HLM 2.49] authorized under Automatic Board Order (ABO) issued as Permit No. 9541, 1974 - Wilbur, McGowan, Zinke). [Additional Reference(s): DWR Levee Logs, 2002. USACE Sacramento O&M Manual 136, March 1960 (HLM 2.49)].<br>FS Date: 4/26/2017 10:46:22 AM | | | | | | |

Waterside view: overview- concrete surg tank

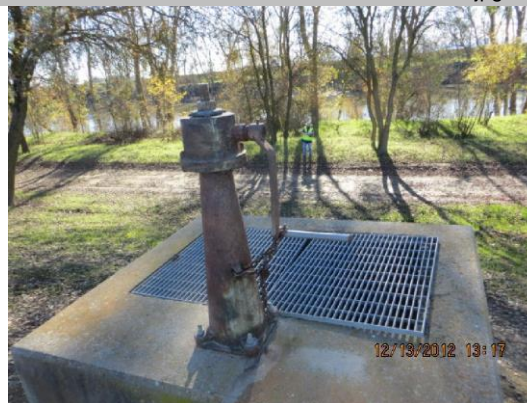
Photo 2 of 3 : UCIP\_SP\_2019\_51660\_47026.jpg

Waterside view: overview- concrete surg tank

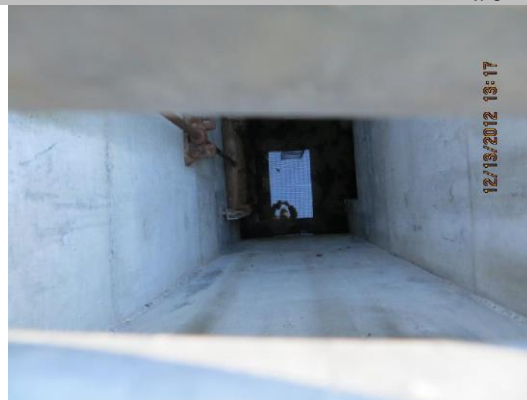
Photo 3 of 3 : UCIP\_SP\_2019\_51660\_47025.jpg

| FS_ID:51660<br>DS_ID:17309<br>EP_NO: 9541<br>Repair Type: Non-Urgent<br>Crossing Status: Found<br>UCIP Comments: 4/24/2017 Still no sign of WS pipe end or flapgate.<br>LS appears to be in good condition. (DWR Sutter Yard- AFreitag)<br><br>11/7/2016 LS culvert measured to be 30"wide X 30"tall. WS end is not visible so could not be measured. (DWR Sutter Yard- AFreitag)6/6/2016 Cannot locate the WS headwall/flapgate. Appears to have been silted over.4/6/2015 Same as last inspection. Concrete surg box on WS. Flap gate in concrete "U" headwall at the waterward end- not found.6/30/2014 Same as last inspection.12/30/2013 Same as last inspection.7/29/2013 Same as last inspection.<br>FIELD_STRUCT_DESC: 30-inch reinforced concrete box drainage culvert through the levee, 14.3 feet below the crown. 30-inch corrugated metal pipe connects concrete culvert from slide gate out to flap gate on the waterside (WS) end. Slide gate in a concrete riser on the waterside (WS) slope. (30-inch pipe [HLM 2.49] authorized under Automatic Board Order (ABO) issued as Permit No. 9541, 1974 - Wilbur, McGowan, Zinke). [Additional Reference(s): DWR Levee Logs, 2002. USACE Sacramento O&M Manual 136, March 1960 (HLM 2.49)].<br>FS Date: 4/26/2017 10:46:22 AM | | | | | | |

Waterside view: slide gate inside concrete surg tank

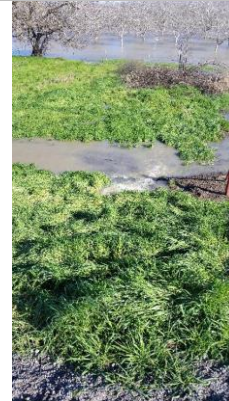
Photo 2 of 3 : UCIP\_SP\_2019\_52949\_76920.jpg

| FS_ID:52949<br>DS_ID:17311<br>EP_NO: N/A<br>Repair Type: Urgent<br>Crossing Status: Found<br>UCIP Comments: 8/30/2018 Pipe found; at a different Lat/Long than is listed, however. Revised Lat/Long is (39.196865, -121.985280; CLM 3.32). WS pipe end is visible and has a functioning slide gate; LS pipe end is exposed with no closure device or headwall. Keeping as Urgent because the LS pipe discharges into a hole and could pose a threat to the levee prism during a high water event. There are also cracks on the crown that could be related to the pipe beneath. Recommend an internal pipe inspection to be sure of the levee integrity (D.Sanoski - DWR UCIP).4/6/2017 Pipe was found in January 2017 during a high water event when water uncovered the buried WS end which led to uncontrolled water flow through during the high water event. The WS pipe opening was temporarily blocked off by plywood and sandbags until the pipe can be properly plugged or abandoned. Pics updated. (DWR Sutter Yard- Afreitag)11/7/2016 Unable to locate. (DWR Sutter Yard- AFreitag)6/6/2016 Unable to locate.4/6/2015 Unable to locate.6/30/2014 Unable to locate.12/30/2013 Unable to locate.7/29/2013 Same as last inspection. Unable to locate. FIELD_STRUCT_DESC: 24-inch corrugated metal drainage pipe through the levee, 12.4 feet below the crown. Slide gate on the waterside (WS) end. (Automatic Board Order (ABO) issued as Permit No. 9539, 1974 - Locvich). [Additional Reference(s): DWR Levee Log, 2002. USACE Sacramento O&M Manual 136, March 1960 (HLM 3.25)]. FS Date: 8/30/2018 1:45:35 PM | | | | | | |

LS view from levee shoulder

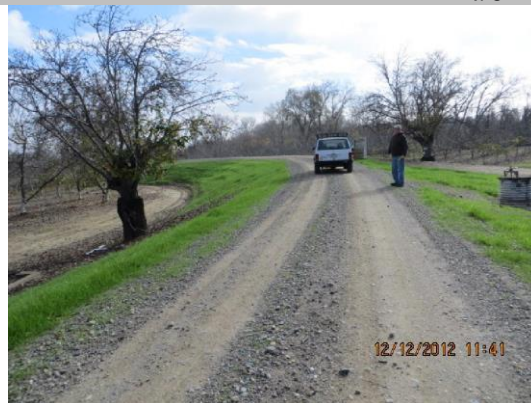
Photo 1 of 3 : UCIP\_SP\_2019\_51698\_47202.jpg

Crown view: overview (both sides of the levee)

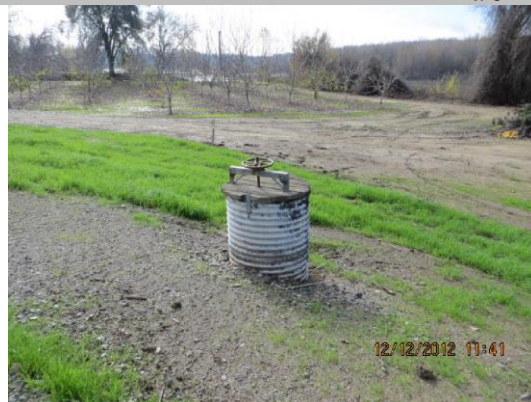
Photo 2 of 3 : UCIP\_SP\_2019\_51698\_47201.jpg

Waterside view: overview of CMP riser

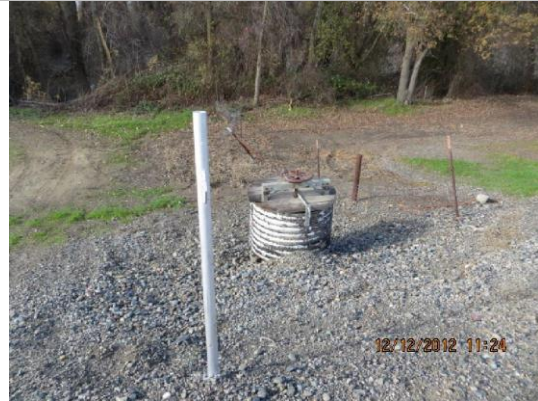
Photo 1 of 3 : UCIP\_SP\_2019\_51725\_47208.jpg

FIELD\_STRUCT\_DESC: \*ABANDONED\* 24-inch irrigation and drainage pipe through the levee, invert 11.5 feet below the crown. Slide gate in a corrugated metal pipe (CMP) riser on the waterside (WS) slope. (24-inch pipe [HLM 8.55] authorized under Automatic Board Order (ABO) issued as Permit No. 9529, 1974 - Dorwood Ranching Co.) [Additional Reference(s): DWR Levee Log, 2002. USACE Sacramento O&M Manual 136, March 1960 (HLM 8.55)]  
FS Date: 5/1/2017 8:37:22 AM

Waterside view: overview of CMP riser

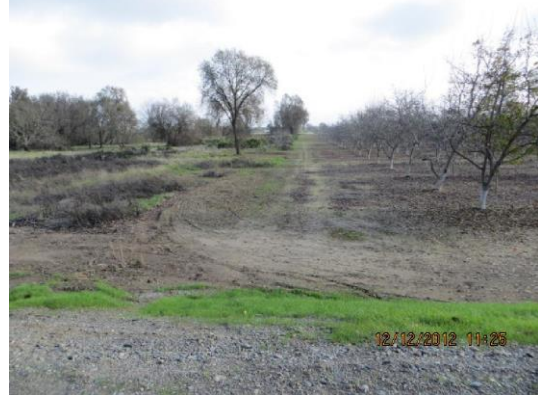
Photo 2 of 3 : UCIP\_SP\_2019\_51725\_47207.jpg

| FS_ID:51725<br>DS_ID:17295<br>EP_NO: 9529<br>Repair Type: No Action Needed<br>Crossing Status: Found<br>UCIP Comments: 09/21/2017 Permit review indicates this 24-inch pipe was authorized as an irrigation and drainage pipe under ABO issued as Permit No. 9529, structure description was updated. Structure type logged as drainage. (DWR UCIP - O. Magana)<br>4/19/2017 Abandoned- needs to be done so properly. (DWR Sutter Yard- Afreitag)10/31/2016 Abandoned. (DWR Sutter Yard- Afreitag)6/13/2016 Pipe was exposed and camera inspected by Nor-Cal Pipeline Services 10/29/2015. Photos of the exposed pipe ends were uploaded on 4/1/2015. The internal inspection showed some signs of rust but no visible holes or deterioration were found. After the inspection the pipe ends were capped and reburied.6/9/2016 Khalida Fazel of UCIP requests that any photos of the pipe when it was exposed for a video inspection be kindly uploaded here.4/4/2016 Proper abandonment of pipe is needed. Pipe has been buried again after it was dug up and video inspected, so was not visible on LS. Note that landowner has regraded LS slope so drainage is now to the east (toward LS).4/1/2015 Both WS and LS pipe ends have been dug up in preparation for an internal camera inspection. Pipe shows signs of heavy rust and both ends of pipe are plugged with soil.Only a CMP riser with slide gate found on WS.6/30/2014 Same as last inspection.12/18/2013 Same as last inspection.7/23/2013 Same as last inspection.<br>FIELD_STRUCT_DESC: *ABANDONED* 24-inch irrigation and drainage pipe through the levee, invert 11.5 feet below the crown. Slide gate in a corrugated metal pipe (CMP) riser on the waterside (WS) slope. (24-inch pipe [HLM 8.55] authorized under Automatic Board Order (ABO) issued as Permit No. 9529, 1974 - Dorwood Ranching Co.) [Additional Reference(s): DWR Levee Log, 2002. USACE Sacramento O&M Manual 136, March 1960 (HLM 8.55)]<br>FS Date: 5/1/2017 8:37:22 AM | | | | | | |

Landside view: overview (no pipes)

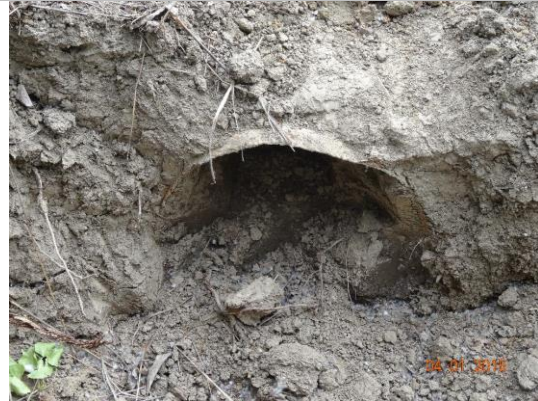
Photo 3 of 3 : UCIP\_SP\_2019\_51725\_73640.jpg

FIELD\_STRUCT\_DESC: \*ABANDONED\* 24-inch irrigation and drainage pipe through the levee, invert 11.5 feet below the crown. Slide gate in a corrugated metal pipe (CMP) riser on the waterside (WS) slope. (24-inch pipe [HLM 8.55] authorized under Automatic Board Order (ABO) issued as Permit No. 9529, 1974 - Dorwood Ranching Co.) [Additional Reference(s): DWR Levee Log, 2002. USACE Sacramento O&M Manual 136, March 1960 (HLM 8.55)]  
 FS Date: 5/1/2017 8:37:22 AM

WS pipe end

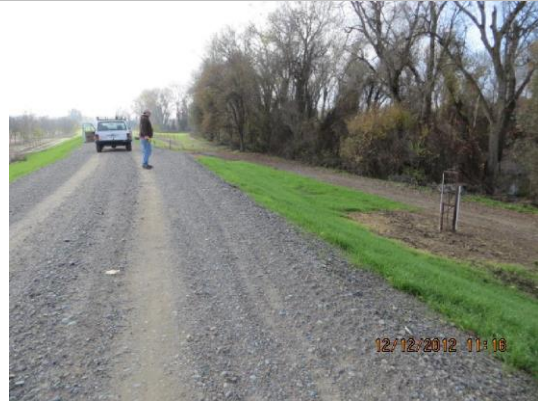
Photo 1 of 3 : UCIP\_SP\_2019\_51726\_47210.jpg

Waterside view: overview

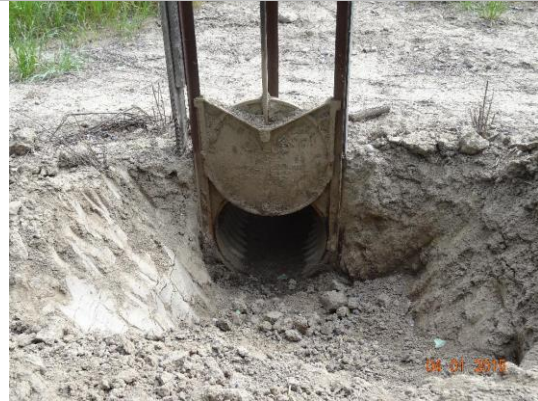
Photo 3 of 3 : UCIP\_SP\_2019\_51726\_73649.jpg

| FS_ID:51726<br>DS_ID:17327<br>EP_NO: 9528<br>Repair Type: Non-Urgent<br>Crossing Status: Found<br>UCIP Comments: 4/19/2017 Abandoned- needs to be done so properly. (DWR Sutter Yard- Afreitag)10/31/2016 Abandoned. (DWR Sutter Yard- Afreitag)6/13/2016 Pipe was internally cleaned and camera inspected by Nor-Cal Pipeline Services on 10/29/2015. Pipe length through levee is 75.1ft long. The inspection showed some signs of rust but no holes or other deterioration were found. Pics of exposed pipe ends were uploaded on 4/1/2015. After the inspection the pipe ends were capped and reburied.4/14/2016- Same as last inspection.4/1/2015- Both ends of pipe have been dug up in preparation for internal camera inspections. Pipe shows some rust but appears to be in decent shape. Only buried slide gate structure found.6/30/2014- Same as last inspection.12/18/2013 Same as last inspection.7/23/2013 Same as last inspection.<br>FIELD_STRUCT_DESC: *ABANDONED* 24-inch corrugated metal drainage pipe through the levee, 12.5 feet below the crown. Slide gate on the waterside (WS). (Automatic Board Order (ABO) issued as Permit No. 9528, 1974 - Lamb). [Additional Reference(s): DWR Levee Log, 2002. USACE Sacramento O&M Manual 136, March 1960 (HLM 8.59)].<br>FS Date: 5/1/2017 8:51:02 AM | | | | | | |

WS pipe end

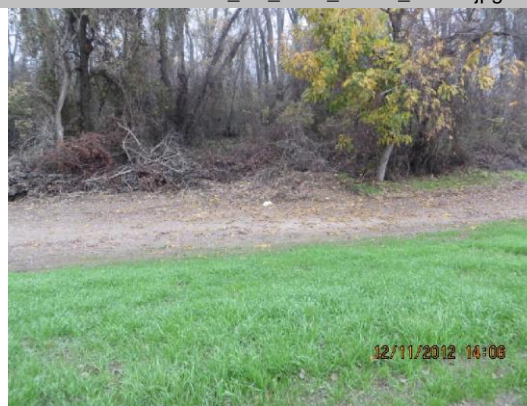
Photo 1 of 3 : UCIP\_SP\_2019\_51731\_47242.jpg

Waterside view: overview

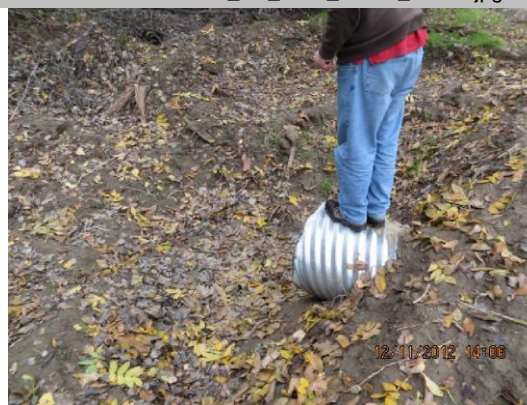
Photo 2 of 3 : UCIP\_SP\_2019\_51731\_47241.jpg

Waterside view: overview of CMP pipe

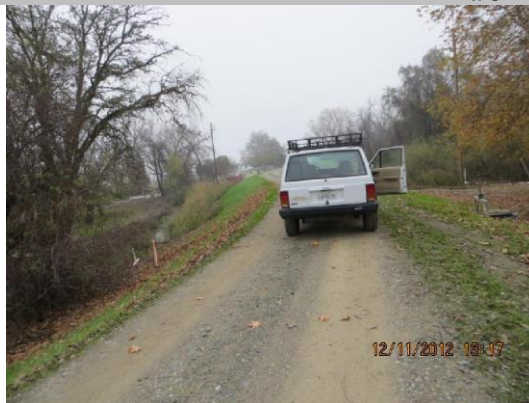
Photo 1 of 3 : UCIP\_SP\_2019\_51734\_47263.jpg

| FS_ID:51734<br>DS_ID:17358<br>EP_NO: 9517<br>Repair Type: No Action Needed<br>Crossing Status: Found<br>UCIP Comments: 4/19/2017 No WS end found/ slide gate handle broken. (DWR Sutter Yard- Afreitag)10/31/2016 Slide gate handle is broken and no WS pipe end can be located. (DWR Sutter Yard- Afreitag)6/1/2016 WS slide gate handle is still broken. No WS pipe end was found.4/1/2015 Slide gate handle is still broken. The rest of the pipe appears in good condition. Broken slide gate handle found on WS.6/30/2014 Same as last inspection.12/18/2013 Same as last inspection.7/23/2013 Same as last inspection.<br>FIELD_STRUCT_DESC: 48-inch corrugated metal drainage pipe through the levee, 14 feet below the crown. Slide gate in a 60-inch corrugated metal pipe (CMP) riser on the waterside (WS) slope. Slide gate in a concrete distribution box on the landside (LS) toe. (48-inch pipe [HLM 10.39] authorized under Automatic Board Order (ABO) issued as Permit No. 9517, 1974 - Griffin). [Additional Reference(s): DWR Levee Log, 2002. USACE Sacramento O&M Manual 136, March 1960 (HLM 10.47)].<br>FS Date: 5/1/2017 9:32:45 AM | | | | | |

Crown view: overview (both sides of the levee)

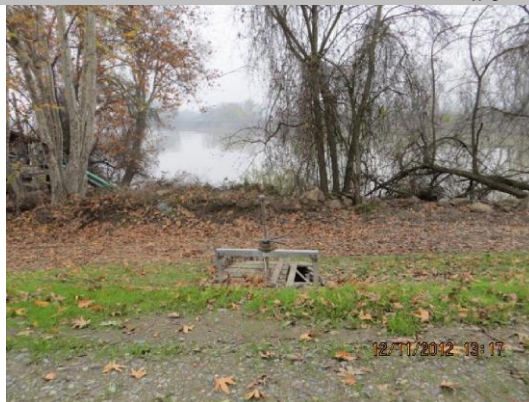
Photo 2 of 3 : UCIP\_SP\_2019\_51734\_47262.jpg

Waterside view: overview of CMP riser

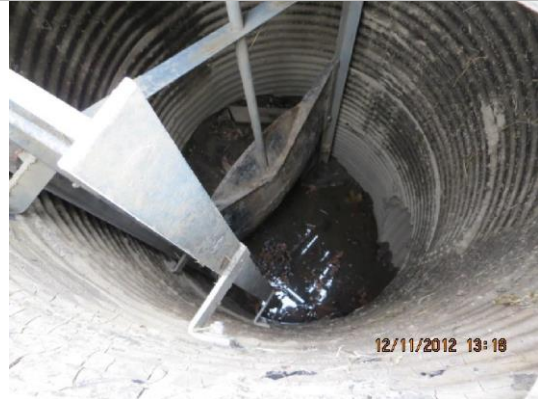
Photo 3 of 3 : UCIP\_SP\_2019\_51734\_47268.jpg

| FS_ID:51734<br>DS_ID:17358<br>EP_NO: 9517<br>Repair Type: No Action Needed<br>Crossing Status: Found<br>UCIP Comments: 4/19/2017 No WS end found/ slide gate handle broken. (DWR Sutter Yard- Afreitag)10/31/2016 Slide gate handle is broken and no WS pipe end can be located. (DWR Sutter Yard- Afreitag)6/1/2016 WS slide gate handle is still broken. No WS pipe end was found.4/1/2015 Slide gate handle is still broken. The rest of the pipe appears in good condition. Broken slide gate handle found on WS.6/30/2014 Same as last inspection.12/18/2013 Same as last inspection.7/23/2013 Same as last inspection.<br>FIELD_STRUCT_DESC: 48-inch corrugated metal drainage pipe through the levee, 14 feet below the crown. Slide gate in a 60-inch corrugated metal pipe (CMP) riser on the waterside (WS) slope. Slide gate in a concrete distribution box on the landside (LS) toe. (48-inch pipe [HLM 10.39] authorized under Automatic Board Order (ABO) issued as Permit No. 9517, 1974 - Griffin). [Additional Reference(s): DWR Levee Log, 2002. USACE Sacramento O&M Manual 136, March 1960 (HLM 10.47)].<br>FS Date: 5/1/2017 9:32:45 AM | | | | | | |

Waterside view: inside CMP riser

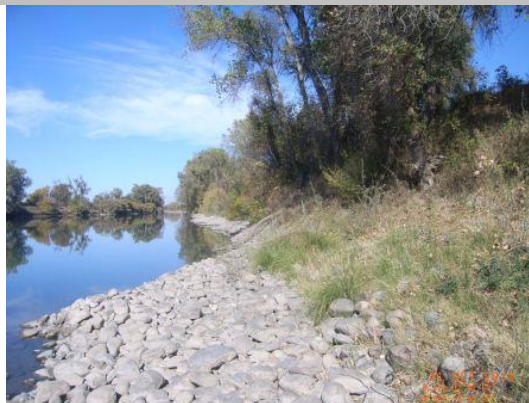
Photo 1 of 1 : SP\_2019\_ST0003\_264\_8\_20190327\_00006.jpg

| Site History: 2008 - Large rotational/mass failure in the bank with tree slump. 2009 - Minimal new erosion, the tree is leaning further into the river. 2011 - Site extended downstream. 2012 - Minor new erosion and tree roots are further exposed. | | | | | |

USACE 2013 Photo #1

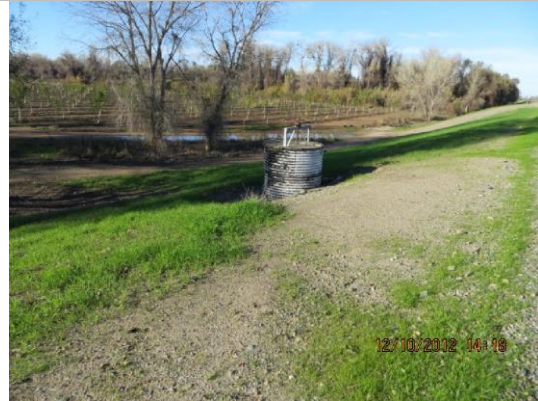
Photo 1 of 3 : UCIP\_SP\_2019\_51749\_47343.jpg

FIELD\_STRUCT\_DESC: \*ABANDONED\* 48-inch corrugated metal drainage pipe through the levee, 16.5 feet below the crown. Slide gate in a 60-inch corrugated metal pipe (CMP) riser on the waterside (WS) slope. Landside (LS) end of pipe on east side of River Road. Pipe is not in use but is operable. (48-inch pipe [HLM 13.37] authorized under Permit No. 9511, 1974 - Moresco). [Additional Reference(s): DWR Levee Log, 2002. USACE Sacramento O&M Manual 136, March 1960 (HLM 13.37)].  
FS Date: 5/1/2017 10:27:34 AM

Waterside view: CMP riser with slide gate

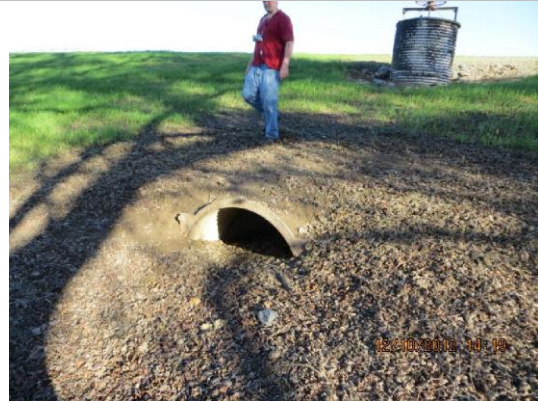
Photo 2 of 3 : UCIP\_SP\_2019\_51749\_47342.jpg

FIELD\_STRUCT\_DESC: \*ABANDONED\* 48-inch corrugated metal drainage pipe through the levee, 16.5 feet below the crown. Slide gate in a 60-inch corrugated metal pipe (CMP) riser on the waterside (WS) slope. Landside (LS) end of pipe on east side of River Road. Pipe is not in use but is operable. (48-inch pipe [HLM 13.37] authorized under Permit No. 9511, 1974 - Moresco). [Additional Reference(s): DWR Levee Log, 2002. USACE Sacramento O&M Manual 136, March 1960 (HLM 13.37)].  
 FS Date: 5/1/2017 10:27:34 AM

Waterside view: overview of CMP riser and outlet pipe

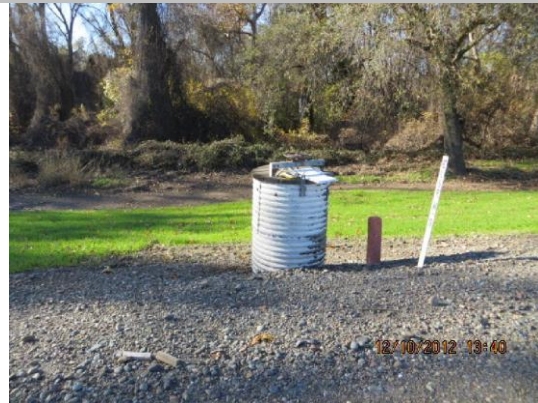
Photo 1 of 3 : UCIP\_SP\_2019\_51752\_47356.jpg

| FS_ID:51752<br>DS_ID:17330<br>EP_NO: 9508<br>Repair Type: No Action Needed<br>Crossing Status: Found<br>UCIP Comments: 4/20/2017 Abandoned- needs to be done so properly. (DWR Sutter Yard- AFreitag)10/31/2016 Appears abandoned. WS pipe end buried. (DWR Sutter Yard- AFreitag)6/14/2016 Pipe was internally cleaned and camera inspected on 11/17/2015 by Nor-Cal Pipeline Services. Pipe section through levee is 86ft long and showed some signs of rusting but no visible holes or other deterioration was found. After the inspection the WS end was capped and reburied until further abandonment can be achieved.4/14/2016 Concrete box on LS cleared of sediment.4/2/2015 Same as last inspection. Concrete box on LS silted in. If abandoned it should be done so properly.7/2/2014 Same as last inspection.12/19/2013 Same as last inspection.7/23/2013 Same as last inspection.<br>FIELD_STRUCT_DESC: 24-inch corrugated metal drainage pipe through the levee, 14 feet below the crown. Slide gate in a 36-inch corrugated metal pipe (CMP) riser on the waterside (WS) slope. Concrete distribution box on the landside (LS). (24-inch pipe [HLM 14.5] authorized under Automatic Board Order (ABO) issued as Permit No. 9508, 1974 - Jones). [Additional Reference(s): DWR Levee Log, 2002. USACE Sacramento O&M Manual 136, March 1960 (HLM 14.5)].<br>FS Date: 5/1/2017 10:34:48 AM | | | | | | |

Waterside view: CMP riser with slide gate

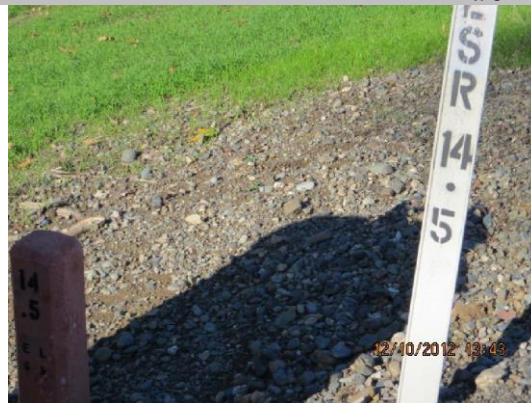
Photo 2 of 3 : UCIP\_SP\_2019\_51752\_47361.jpg

Waterside view: levee mile marker

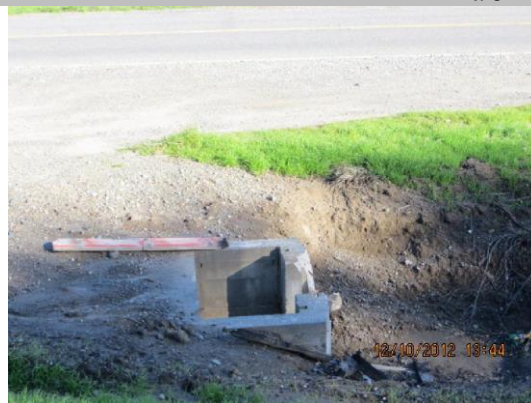
Photo 3 of 3 : UCIP\_SP\_2019\_51752\_47360.jpg

Landside view: overview of distribution box

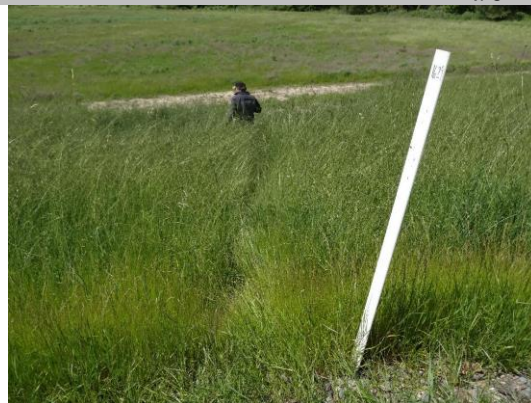
Photo 1 of 3 : UCIP\_SP\_2019\_51759\_75096.jpg

View from crown down WS slope at location of crossing.

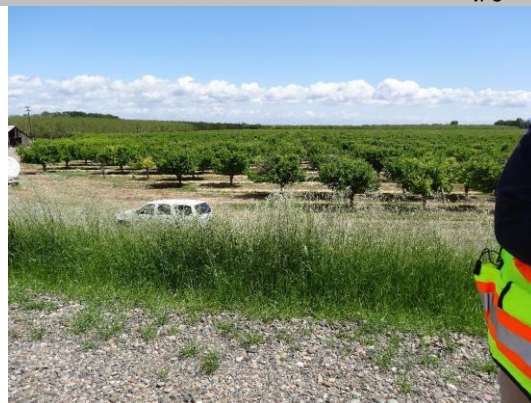
Photo 2 of 3 : UCIP\_SP\_2019\_51759\_75097.jpg

View of LS from crown at location of crossing.

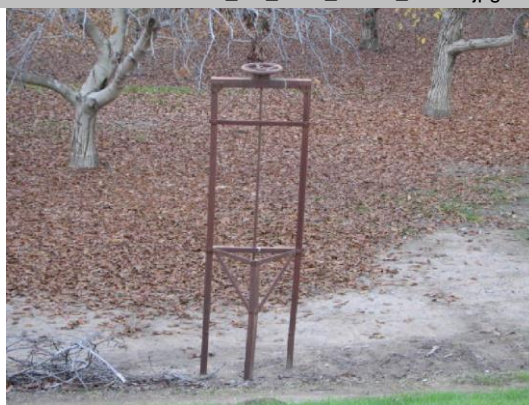
Photo 2 of 3 : UCIP\_SP\_2019\_51762\_47386.jpg

Waterside view: slide gate steel structure

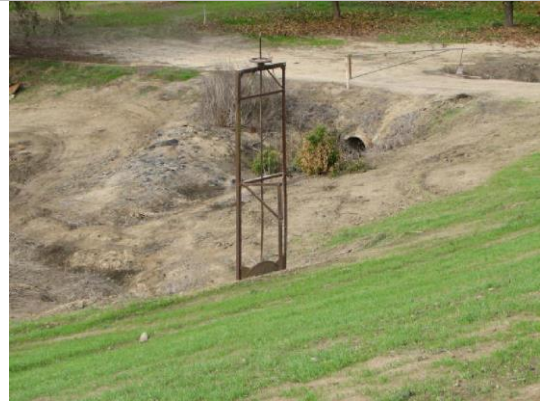
Photo 1 of 3 : UCIP\_SP\_2019\_51770\_47399.jpg

Waterside view: overview of sliding gate structure

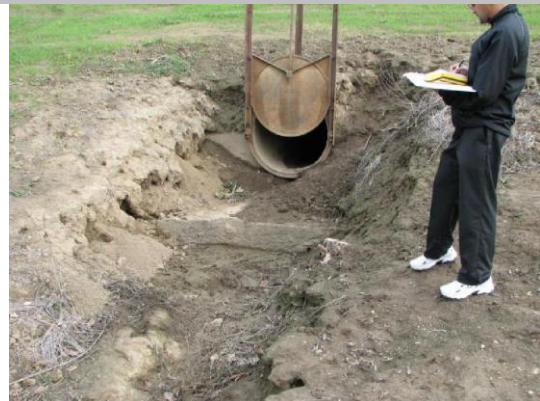
Photo 2 of 3 : UCIP\_SP\_2019\_51770\_47398.jpg

FS\_ID:51770  
DS\_ID:17345  
EP\_NO: N/A  
Repair Type: No Action Needed  
Crossing Status: Found  
UCIP Comments: 4/20/2017 Crossing appears to be in good condition. (DWR Sutter Yard- AFreitag)11/1/2016 Crossing appears to be in good condition. (DWR Sutter Yard- AFreitag)6/16/2016 Pipe was internally cleaned and camera inspected on 11/19/2015 by Nor-Cal Pipeline Services. Pipe is 155ft in total length and the inspection showed some minor rusting but no holes or other deformations were found. Pipe is still used by the landowner for irrigation and the sloughing near the WS end was repaired and rocked to prevent future sloughing or erosion.4/14/2016 Sloughing repaired by Sutter Yard with rock revetment.4/2/2015 Same as last inspection. Pipe has been selected for internal camera inspection.Sloughing at outlet and levee slope is damaged due to sloughing.7/2/2014 It is not an abandoned crossing. Sloughing at outlet and levee slope is damaged due to sloughing.12/19/2013 Same as last inspection.7/24/2013 Same as last inspection.

Waterside view: outlet pipe with concrete headwall and floor apron.

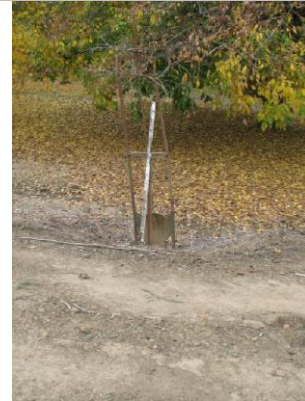
Photo 1 of 3 : UCIP\_SP\_2019\_51771\_47442.jpg

FS\_ID:51771  
DS\_ID:17346  
EP\_NO: 9503  
Repair Type: No Action Needed  
Crossing Status: Found  
UCIP Comments: 4/20/2017 Crossing appears to be in good condition. (DWR Sutter Yard- AFreitag)11/1/2016 Crossing appears to be in good condition. (DWR Sutter Yard- AFreitag)6/16/2016 Pipe was internally cleaned and camera inspected on 11/19/2015 by Nor-Cal Pipeline Services. 129.5 ft (starting from the WS end) was inspected to get get us through the levee prism but the LS end was never found. Pipe showed no signs of rust or damage.4/14/2016 Inlet structure still filled with soil.4/2/2015 Same as last inspection. Pipe has been selected for internal camera inspection.According to local people, the crossing is functional. The gap between 8-inch and 24-inch pipes is grouted with cement. Inlet structure is filled with soil.7/2/2014 Same as last inspection.12/19/2013 Same as last inspection.7/24/2013 Same as last inspection.

Waterside view: overview of slide gate structure

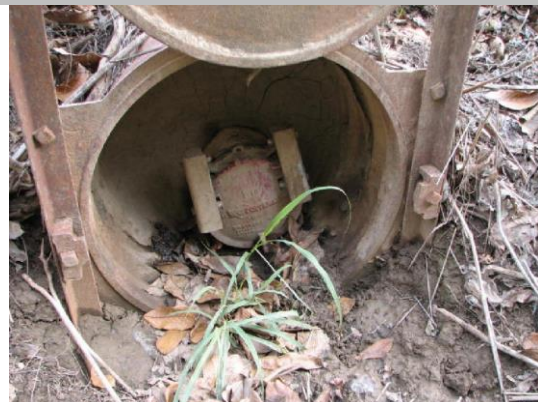
Photo 2 of 3 : UCIP\_SP\_2019\_51771\_47441.jpg

Waterside view: 8-inch pipe inside 24-inch CMP

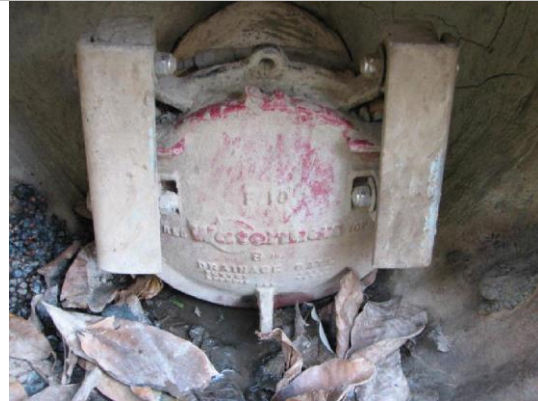
Photo 3 of 3 : UCIP\_SP\_2019\_51771\_47440.jpg

FIELD\_STRUCT\_DESC: 24-inch corrugated metal drainage pipe through the levee, 19 feet below the crown. 8-inch steel pipe sleeved through the 24-inch pipe. Annular space cement grouted. Slide gate at the waterside (WS) toe. Concrete inlet box on the landside (LS). (24-inch pipe [HLM 18.74] authorized under Automatic Board Order (ABO) issued as Permit No. 9503, 1974 - Baird). [Additional Reference(s): DWR Levee Log, 2002. USACE Sacramento O&M Manual 136, March 1960 (HLM 18.74)].  
 FS Date: 5/1/2017 10:53:44 AM

Waterside view: 8-inch pipe and drain gate

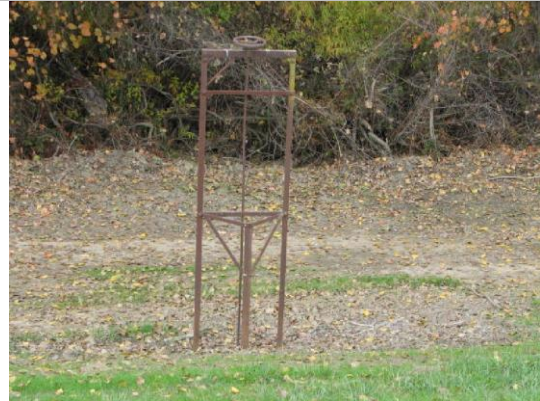
Photo 1 of 3 : UCIP\_SP\_2019\_51773\_47447.jpg

| FS_ID:51773<br>DS_ID:17347<br>EP_NO: N/A<br>Repair Type: No Action Needed<br>Crossing Status: Found<br>UCIP Comments: 4/20/2017 Abandoned- plugged. (DWR Sutter Yard-AFreitag)11/1/2016 Abandoned/plugged. (DWR Sutter Yard-AFreitag)6/16/2016 Internal camera inspection was done on 11/19/2015 by Nor-Cal Pipeline Servies. Pipe was inspected starting from the WS end and inspected upto the grout plug that is 13.7ft into the pipe. Pipe was then capped and reburied until further abandonment can be achieved.4/2/2015 WS end of pipe was dug up in preparation for internal camera inspection. Only steel slide gate structure found on WS.7/2/2014 Same as last inspection.12/19/2013 Same as last inspection.7/24/2013 Same as last inspection.<br>FIELD_STRUCT_DESC: *ABANDONED* 36-inch corrugated metal drainage pipe through the levee, 21.7 feet below the crown. Slide gate at the waterside (WS) toe. Pipe grouted on the WS end. [Additional Reference(s): DWR Levee Log, 2002. USACE Sacramento O&M Manual 136, March 1960 (HLM 19.24)].<br>FS Date: 5/1/2017 10:55:06 AM | | | | | |

Waterside view: overview of abandoned slide gate structure

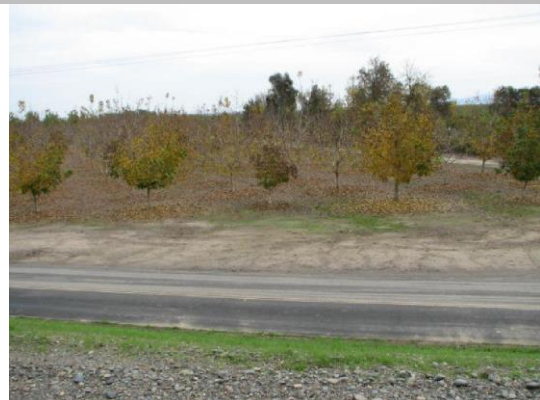
Photo 2 of 3 : UCIP\_SP\_2019\_51773\_47446.jpg

Landside view: overview (no pipes)

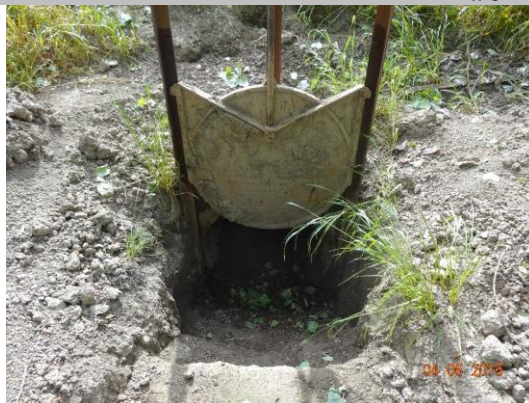
Photo 3 of 3 : UCIP\_SP\_2019\_51773\_73781.jpg

WS pipe end and screw gate

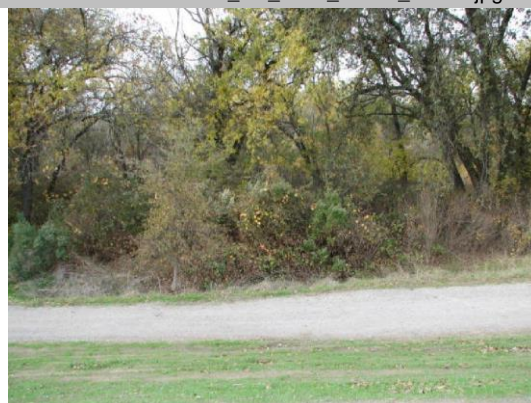
Photo 1 of 3 : UCIP\_SP\_2019\_51775\_47449.jpg

| FS_ID:51775<br>DS_ID:17487<br>EP_NO: N/A<br>Repair Type: Non-Urgent<br>Crossing Status: Found<br>UCIP Comments: 4/20/2017 Abandoned- needs to be done so properly. (DWR Sutter Yard- A Freitag)11/1/2016 Abandoned.(DWR Sutter Yard- A Freitag)6/3/2016 Abandoned crossing.4/2/2015 Same as last inspection. Slide Gate WS not found. An abandoned pump and steel pipe found on WS. A 6 ft x 8 ft concrete distribution box with a CMP found on LS. Box filled with soil. An abandoned crossing.7/2/2014 Same as last inspection.12/19/2013 Same as last inspection.7/24/2013 Same as last inspection.<br>FIELD_STRUCT_DESC: *ABANDONED* 36-inch corrugated metal drainage pipe through the levee, invert 21.7 feet below the crown. Abandoned pump and steel pipe found on the waterside (WS). 6 foot by 8 foot concrete distribution box with the 36-inch corrugated metal pipe found on the landside (LS). [Additional Reference(s): USACE Sacramento O&M Manual 136, March 1960 (HLM 19.61)].<br>FS Date: 5/1/2017 10:56:50 AM | | | | | |

Waterside view: overview
